Manges Cabin Roof Replacement
Summer 2007
Greg Dodson, Hank McCurdy

Start Date: June 4, 2007

Completion Date: July 12, 2007

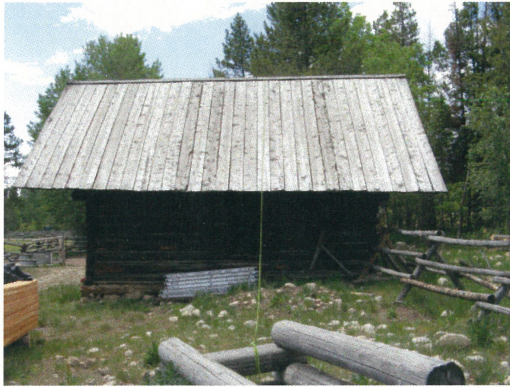
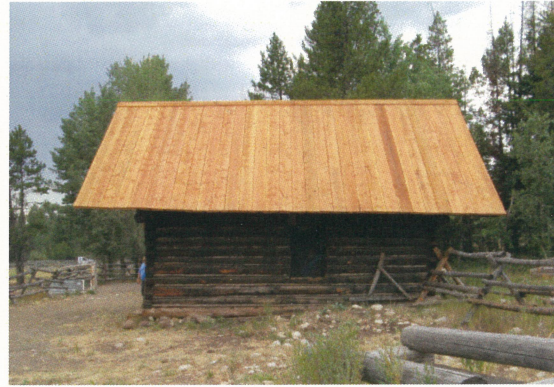
Site description: Manges cabin roof consists of vertically laid 1"x12"x18' rough-cut pine boards. The roof pitch is steep and the overhang is approximately 6 feet. The roof is constructed of two layers of vertical board with staggered joints. In between the two layers of boards there was a layer of 30 lb. felt. 32 foot purlins support the roofing running parallel with the eave, and three 18' rafters run horizontally between northern and southern roofs.

Project Objective: to remove all deteriorated roofing material and replace in-kind with new material.

Project Overview: WCHP staff removed all boards on the south side of the roof, one layer of 30 lb felt, and two and a half purlins. On the north side, WCHP removed only the top layer of boards and one layer of felt. All deteriorated materials were replaced and original materials in good condition were treated with wood preservative and reinstalled on the roof. A failing roof cap was removed and replaced in-kind (with the addition of 14" flashing underneath the cap). Three pine wedges on the south side of the roof which connected the horizontal rafters with the roof purlins were replicated and replaced by new pine wedges.
